# PREVENTING CRACKING AT DIAPHRAGM/PLATE GIRDER CONNECTIONS IN STEEL BRIDGES

Sponsored by the  
Iowa Department of Transportation  
and the Iowa Highway Research Board  
Iowa DOT Project HR-393

JUNE 1998

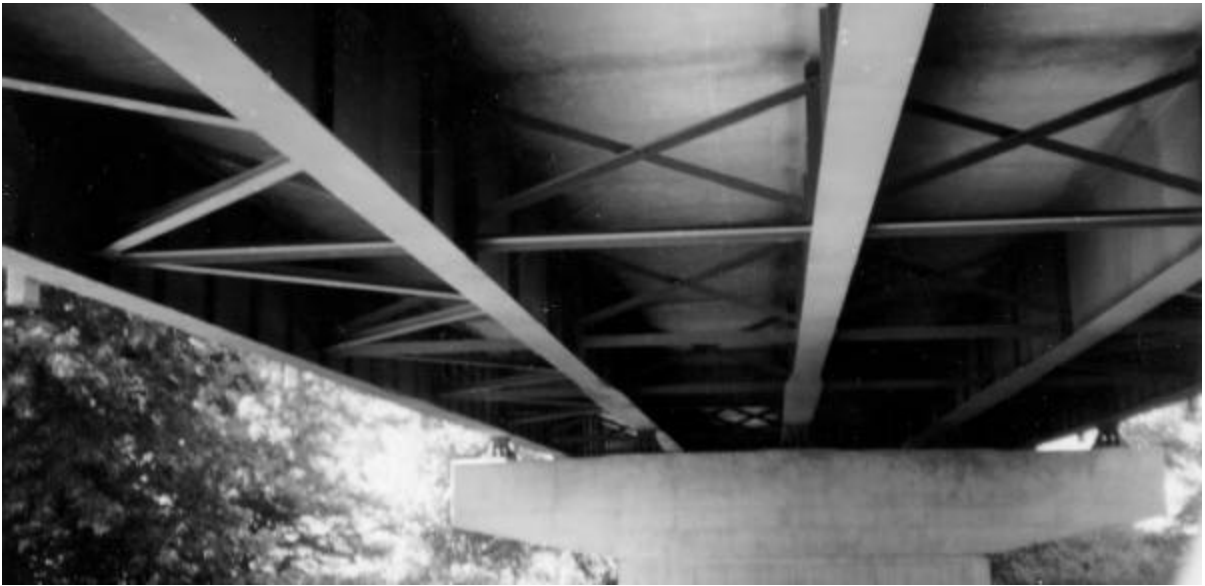
(a) Overview and roadway

(b) Diaphragm system

Figure 2. Boone River Bridge on IA-17 (Bridge X1)

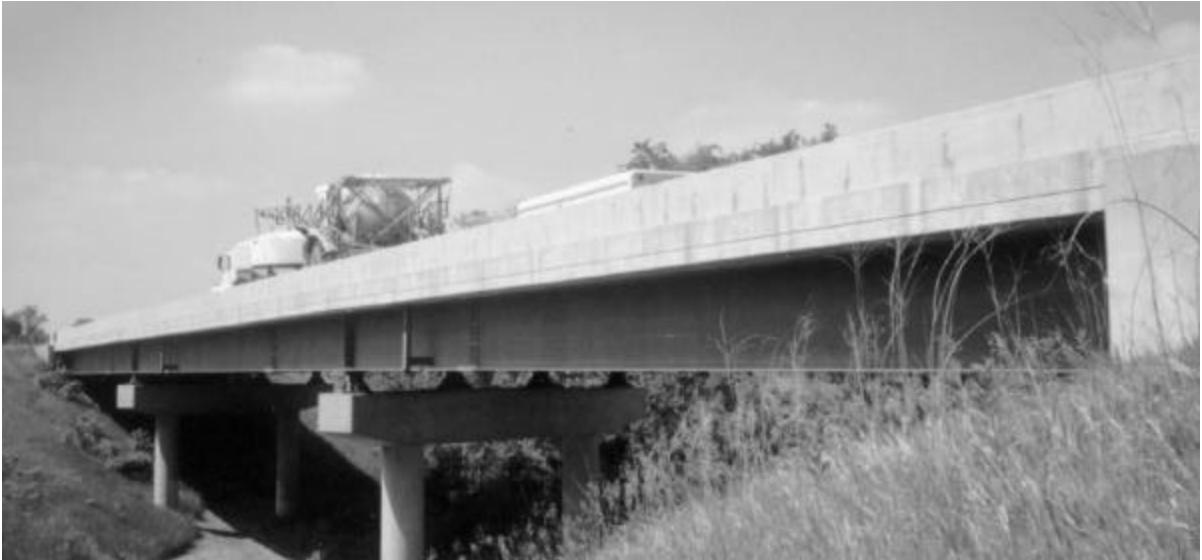
(a) Overview

(b) Diaphragm system

Figure 4. The I-80 Bridge no. 7804.8L080 (Bridge X3)

This bridge (Br. No. 7804.8L080) is located in Pottawattamie County, 3.7 miles (5.9 km) west of the junction of Interstate 80 (I-80) with U.S. 6 Highway. It carries the westbound traffic of I-80 over an abandoned railroad (Figure 4). The bridge was constructed in 1965. The superstructure consists of four continuous steel plate girders topped by a reinforced concrete deck slab. The girders have three spans of 91.5, 117, and 91.5 ft (27.9, 35.7, and 27.9 m), respectively, with a lateral spacing of 9 ft-8 in. (2.9 m) and a total bridge width of 32 ft (9.8 m). The bridge has X-type diaphragms spaced at approximately 22 ft (6.7 m) intervals. The bridge superstructure is skewed  $30^\circ$ , and its supporting two piers and two stub reinforced concrete abutments are supported on piles. Vertical stiffeners are provided at intervals that do not exceed 3 ft-7 in. (1.1 m). Stiffeners are closely fitted to the tension flange with an average web gap height of 1.75 in. (44 mm). Fatigue cracks have been detected in the web gap region at nine locations. As a retrofit, holes were drilled at the crack tips. However, the cracks extended beyond the drilled holes in some locations. Crack extensions were treated by drilling holes at the new crack tip locations. The last fatigue-type inspection of the bridge was in September 1995. The bridge was tested on July 29, 1997. This bridge is referred to as Bridge X3.

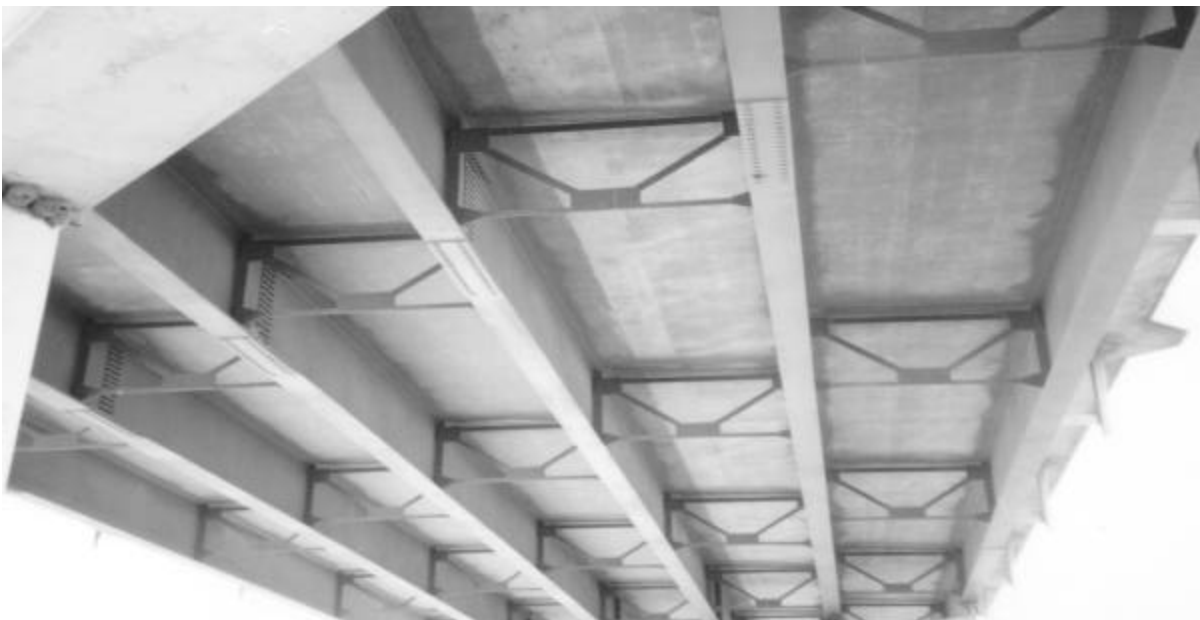
(b) Diaphragm system

Figure 5. The I-80 Bridge over the Mosquito Creek (Bridge K1)

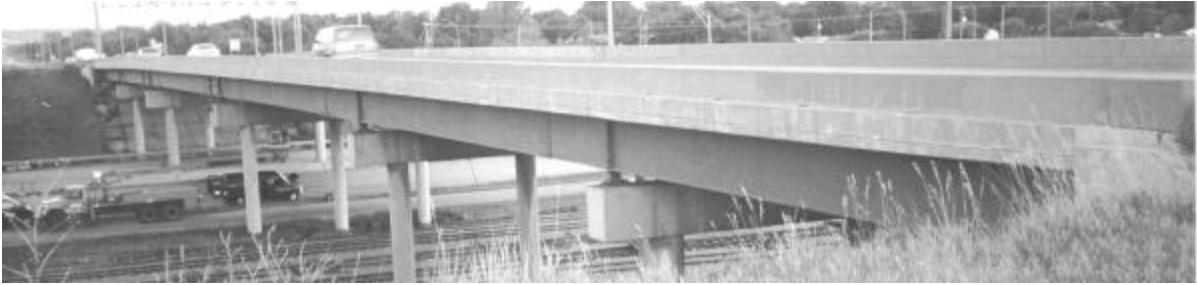
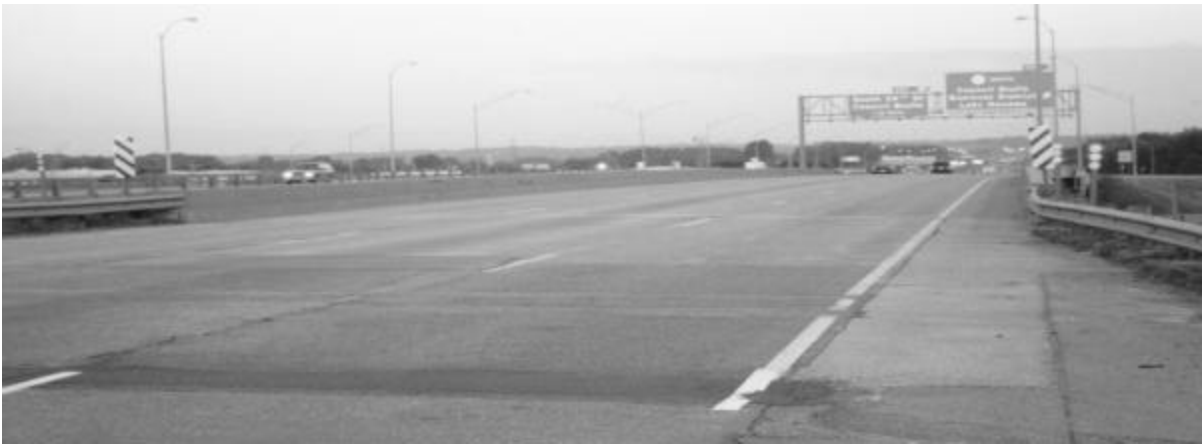
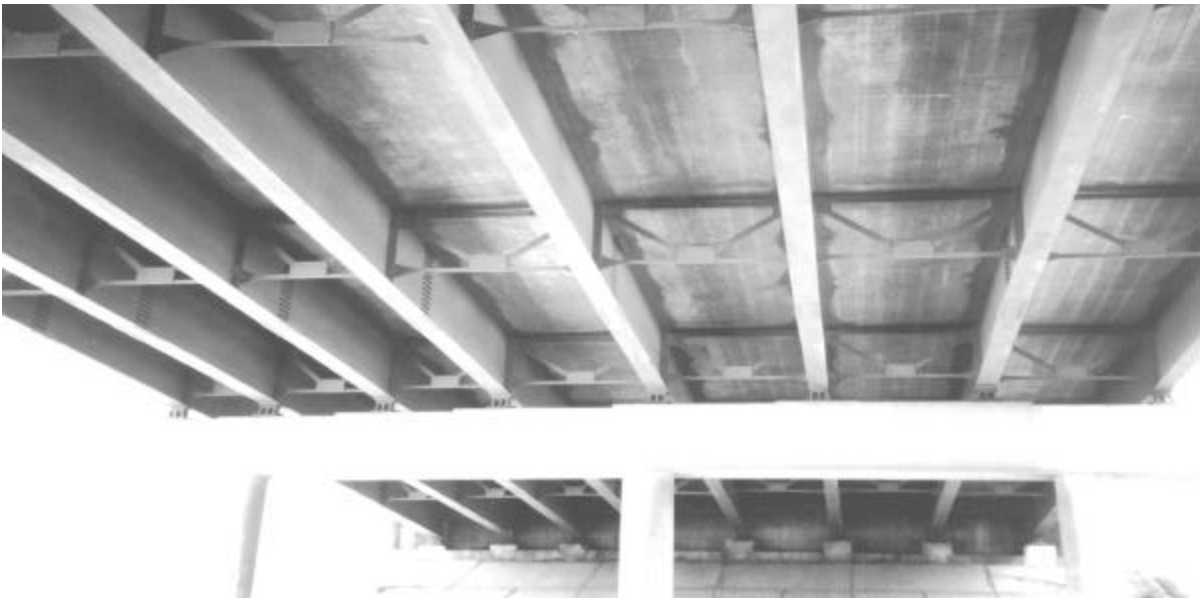
(c) Diaphragm system

Figure 6. The I-80 Bridge over IA-192 (Bridge K2)

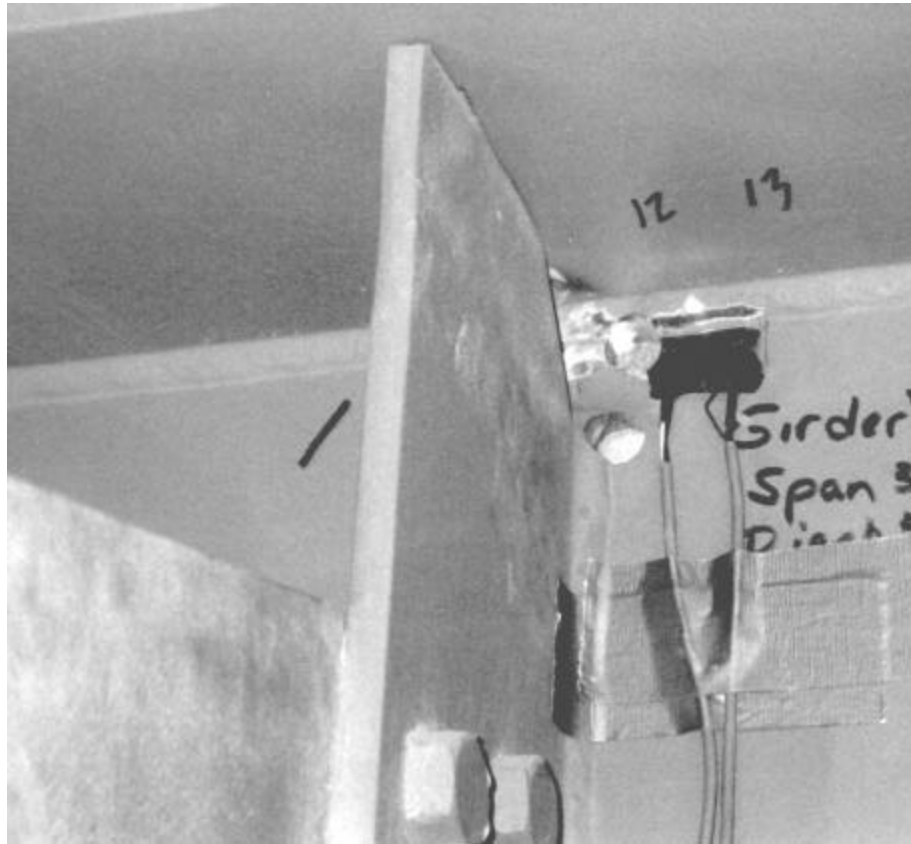
(b) Drilled holes and cracks

Figure 16. Crack and drilled holes at Location HX3

In addition, for bridges where holes were drilled, sensors were located at the cracked web gap (with diaphragm connection in the negative moment region) with the greatest out-of-plane moments. These are Locations HX3 and HK1 for Bridges X3 and K1, respectively. Figure 16 is a photo for Location HX3 with horizontally oriented cracks and drilled holes. In these locations (HX3 and HK1), the horizontal distribution of the out-of-plane distortion strains and the horizontal out-of-plane displacement were measured. Web gaps of interior girders in the negative moment regions are also susceptible to fatigue cracking. Therefore, four locations were instrumented: IX1, IX3, IK1, and IK2, respectively. At these locations, the out-of-plane distortion was recorded. Further, the strain distribution in the web gap region due to the out-of-plane distortion was measured (using at least three strain gages) in all of them except Location IX1. For Location IX1, two vertically oriented displacement transducers were attached on either side of the web to measure the relative vertical displacement between the flange and the web.
